Inspection Report

Property Address: 123 Any Street TN

Home Inspectors of Middle Tennessee LLC

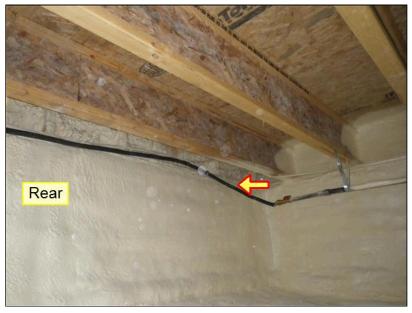
1.2 (Picture 6)

Some gas piping in this house includes TRACEPIPE, Gastite or other sheathed CSST (corrugated stainless steel tubing). There is no visible electrical bonding connection between the gas piping system and the electrical system, other than connections at the gas appliances that utilize the grounding connectors for the appliances. The lack of a strong electrical bonding may increase the potential for lightning strikes to cause arcing at the CSST gas piping that may result in perforation of the piping, gas leaks, and fires. For safety, it is recommended that this installation be further investigated by a licensed electrical contractor. Visit http://www.csstsafety.com/CSST-solution.html for additional information.

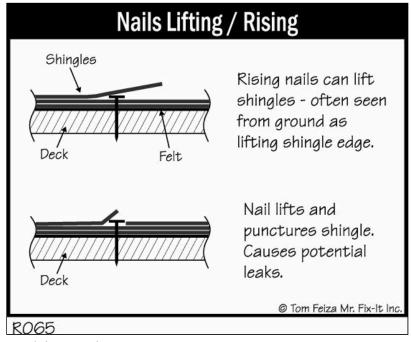
2.1 (Picture 1)

2.1 Nail pop present at pictured location. This is generally caused when the shingle nails are driven at an incorrect angle or the air nailer does not have enough pressure. If left unattended the nails can force through the shingles. Repairs needed.

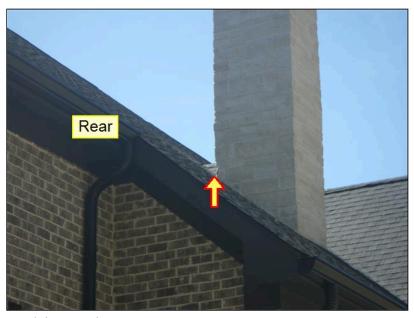
2.1 (Picture 3)

Cricket for chimney appears undersized due to slope of roof. While I cannot confirm, I recommend ensuring with the builder this cricket is sufficient to divert water and prevent leakage.

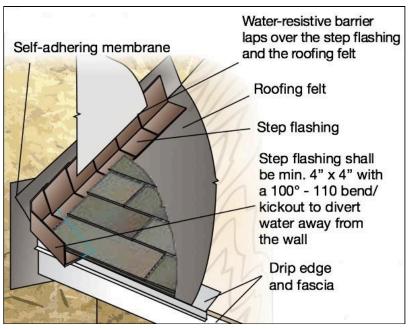
2.3 (Picture 1)

2.3 Kick out diverter flashing needed anywhere a roof and exterior wall intersect, where the wall continues past the lower roof-edge and gutter. Recommend builder evaluate further and make repairs where needed. (Required since 2009)

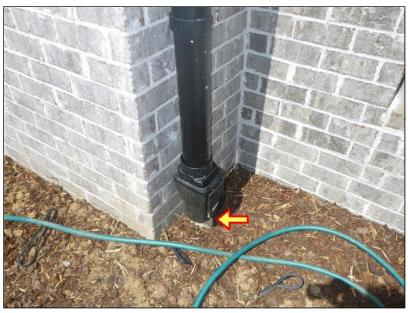
2.7 (Picture 1)

I did not find all termination points.

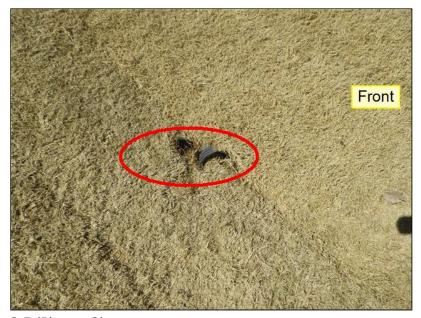
2.7 (Picture 2)

Landscape pop ups or screens at drain extensions need installing to prevent extensions from clogging.

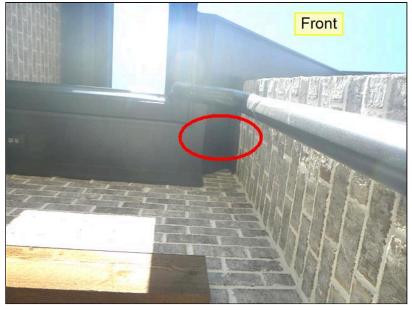
3.0 (Picture 1)

3.0 Gap at soffit is large enough for bird and insect entry. Correction needed.

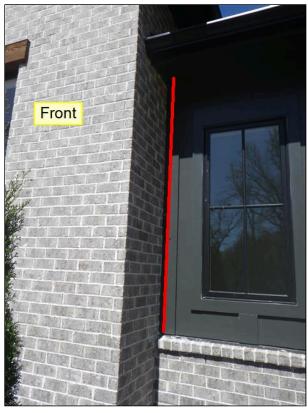
3.1 (Picture 2)

Counter flashing needed anywhere brick meets cement fiber board to prevent moisture intrusion. Builder to further evaluate and repair as needed. Not all locations pictured.

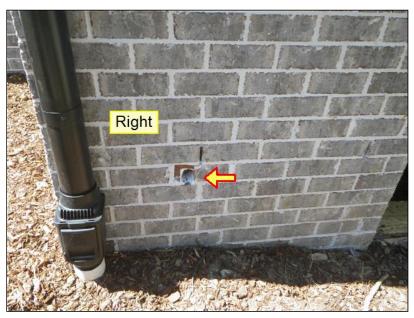
3.2 (Picture 1)

3.2 Masonry repair needed at the pictured areas. Builder to correct.

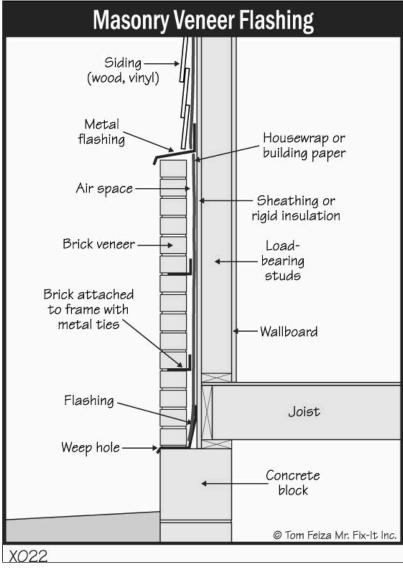
3.2 (Picture 4)

The 1995 CABO (Council of American Building Officials) and the 1994 Standard Building Code call for flashings and weep holes in masonry veneer. Weep holes were not installed on this home at some locations. Weep holes are intended to allow water to exfiltrate and air to infiltrate the wall cavity. Ideally weep holes should be provided in masonry veneer and in the outside wythe of the masonry walls at a maximum spacing of 4 feet on center by omitting mortar in the head joints. Weep holes should be located in the first course above the foundation wall or slab, and other points of support, including structural floors, shelf angles, and lintels above windows. Correction needed at all applicable locations.

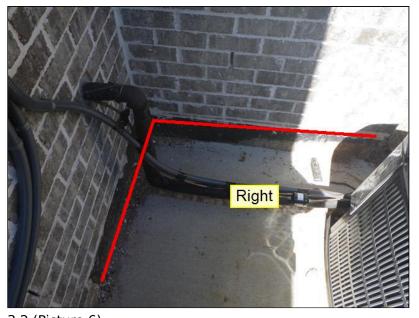
3.2 (Picture 6)

Masonry repair needed at pictured location where foundation block is visible. Builder to correct.

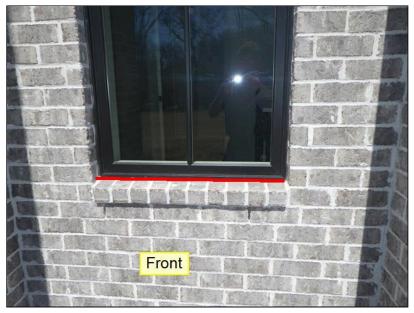
5.0 (Picture 1)

5.0 All windows set in brick need sealing at the exterior sill to prevent moisture intrusion. Builder to correct. Not all pictured.

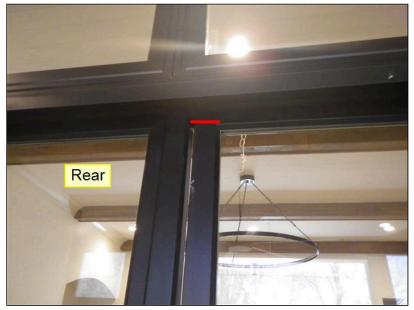
5.2 (Picture 7)

Pictured door rubs and needs adjustment.

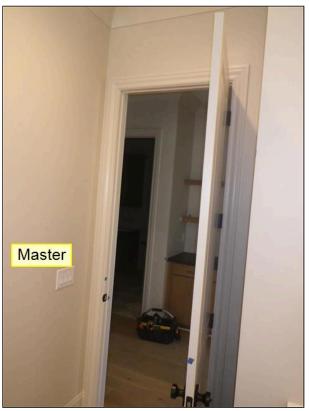
7.4 (Picture 1)

7.4 Pictured door needs to be adjusted to prevent swinging open/close.

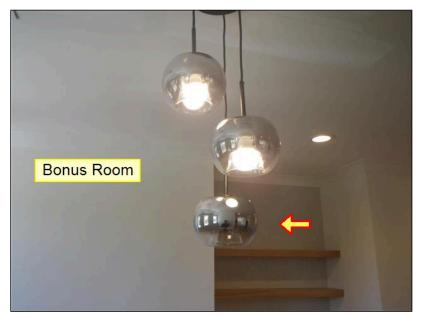
8.7 (Picture 2)

Missing bulb. Correction needed.

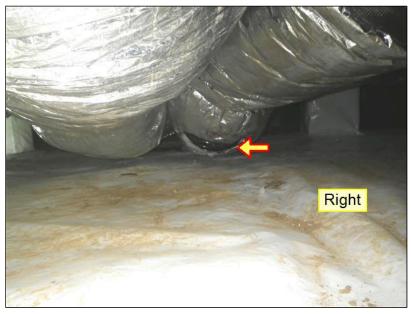
9.3 (Picture 3)

Damaged duct insulation in crawlspace needs repairing by builder.

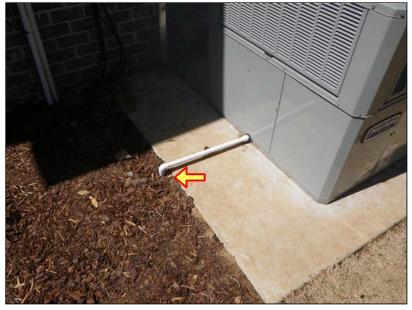
10.3 (Picture 1)

10.3 Condensation lines should not be terminating under ground as this can cause the lines to back up which will cause failure or damage to the unit. Correction needed. A condensation pit or well may also be considered. These are generally 8 to 10 inches deep filled half with gravel and are located at condensation line termination points.

No visible trap on this line. It may be underground if not builder should correct as required.

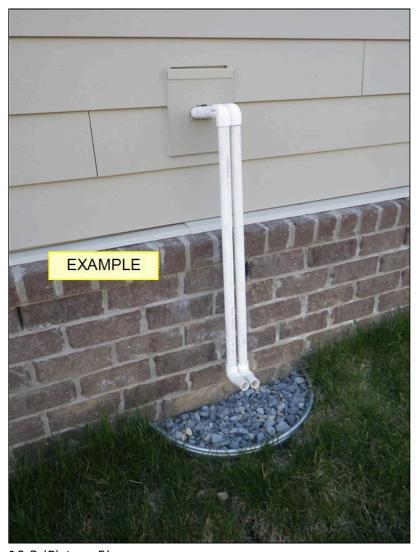
10.3 (Picture 5)

Recommend extending condensation and/or overflow lines at least six feet away from home. These lines carry large volumes of water during high use periods. A condensation pit or well may also be considered. These are generally eight to ten inches deep filled half with gravel and are located at condensation line termination points.

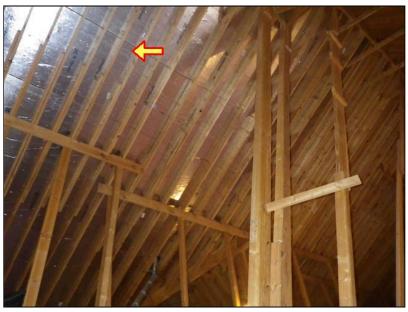
11.1 (Picture 1)

The installation of TechShield inhibits the inspection of the roof sheathing.

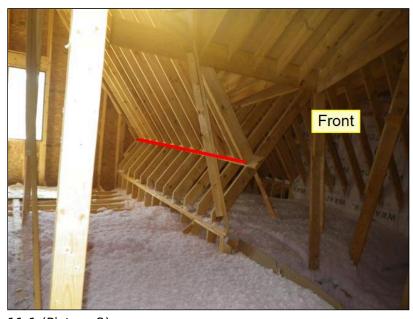
11.1 (Picture 2)

Numerous joists in the attic are missing strong ties that aid in supporting the joists at end cuts. Face nailing alone is not sufficient. Correction needed by builder.

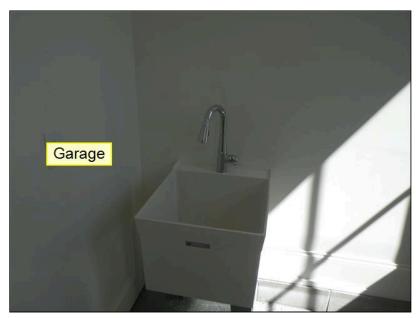
13.0 (Picture 1)

Water off to pictured fixture. Builder to ensure proper functionality of component.

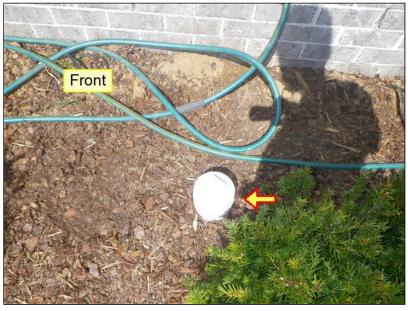
13.2 (Picture 1)

13.2 FYI - Sewage clean out. Plumber can access this clean out in case of plumbing backup.

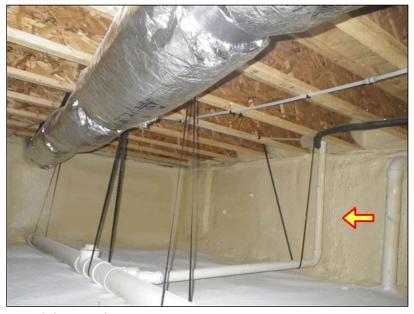
15.0 (Picture 1)

15.0 Most of the foundation wall, band joist and sill plate was not visible due to insulation.

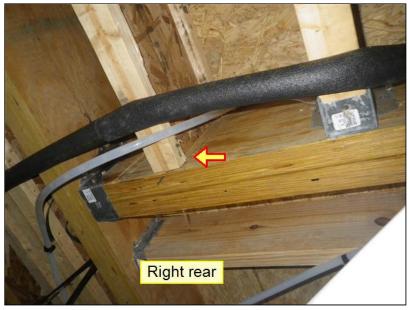
15.1 (Picture 1)

15.1 Pictured floor joist is missing joist hanger. Face nailing alone is not sufficient. Recommend builder evaluate further and make appropriate repair.

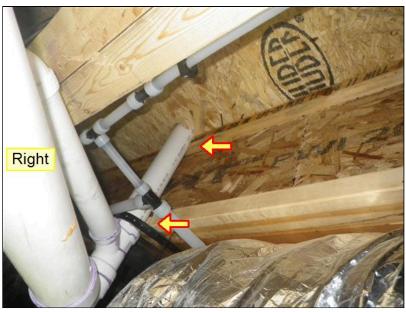
15.1 (Picture 3)

Truss joist installation guidelines indicate "do not cut or notch flange". Doing so weakens the joist. Pictured flange is damaged by tradesmen and needs repair or replace per manufacturers guidelines. Further evaluation and repair by builder is needed.

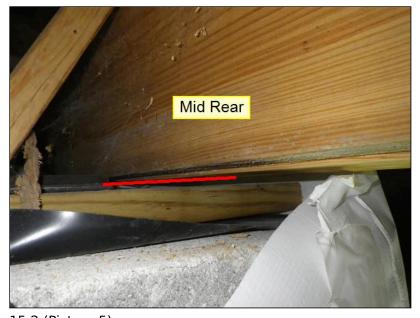
15.2 (Picture 5)

At least one pier in the crawl space is not shimmed to the adjacent girder. Proper shimming required to provide adequate support. While repairs are being made suggest all piers be reinspected and repaired if needed.

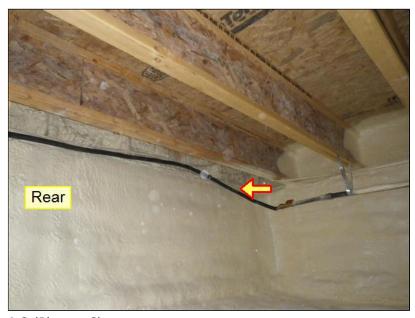
1.2 (Picture 6)

Some gas piping in this house includes TRACEPIPE, Gastite or other sheathed CSST (corrugated stainless steel tubing). There is no visible electrical bonding connection between the gas piping system and the electrical system, other than connections at the gas appliances that utilize the grounding connectors for the appliances. The lack of a strong electrical bonding may increase the potential for lightning strikes to cause arcing at the CSST gas piping that may result in perforation of the piping, gas leaks, and fires. For safety, it is recommended that this installation be further investigated by a licensed electrical contractor. Visit http://www.csstsafetv.com/CSST-solution.html for additional information.

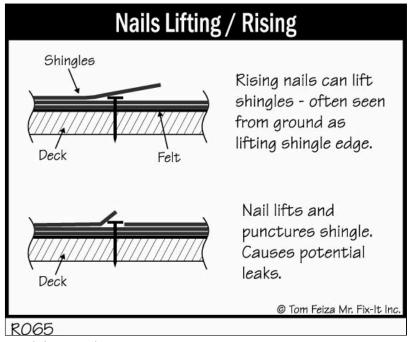
2.1 (Picture 1)

123 Any Street Page 62 of 94 Nail pop present at pictured location. This is generally caused when the shingle nails are driven at an incorrect angle or the air nailer does not have enough pressure. If left unattended the nails can force through the shingles. Repairs needed.

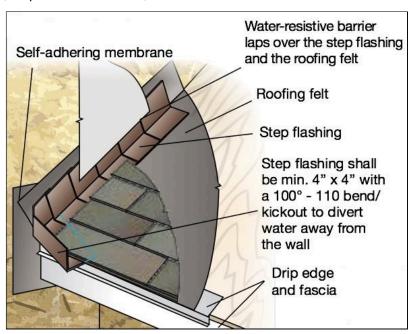
2.3 (Picture 1)

Kick out diverter flashing needed anywhere a roof and exterior wall intersect, where the wall continues past the lower roof-edge and gutter. Recommend builder evaluate further and make repairs where needed. (Required since 2009)

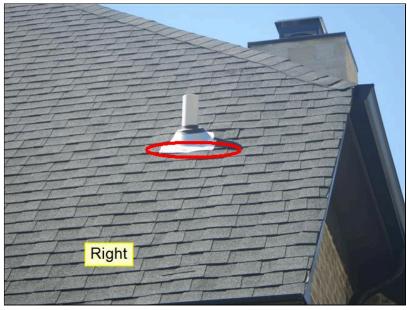
2.5 (Picture 1)

Nail penetrations are an obvious source of potential moisture intrusion. All exposed nail heads must be sealed as per most shingle manufacture installation guidelines. While repairs are being made I recommend builder inspect all roof penetrations.

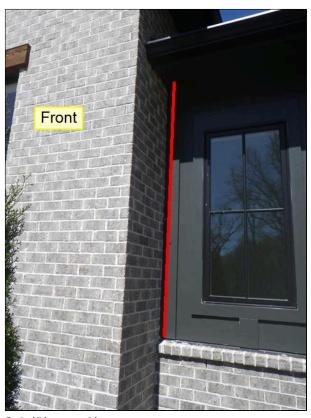
3.1 (Picture 1)

Counter flashing needed anywhere brick meets cement fiber board to prevent moisture intrusion. Builder to further evaluate and repair as needed. Not all locations pictured.

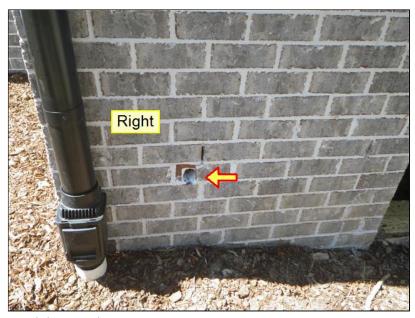
3.2 (Picture 1)

Masonry repair needed at the pictured areas. Builder to correct.

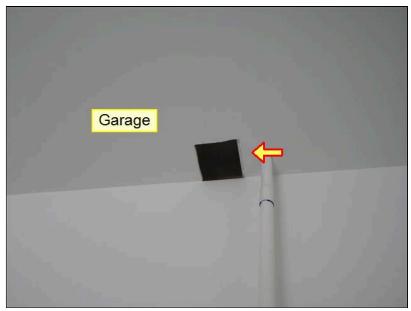
7.1 (Picture 1)

Maintenance Repair or Replace Builder to patch opening in drywall.

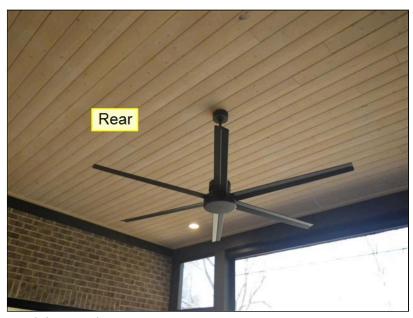
8.7 (Picture 1)

I was unable to get the pictured fan to spin during the inspection. Correction needed.

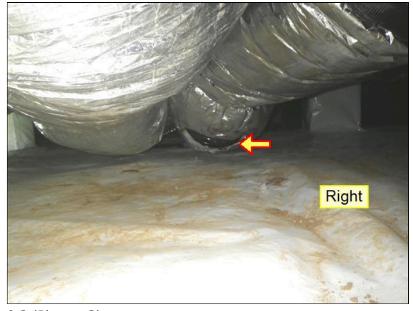
9.3 (Picture 3)

Damaged duct insulation in crawlspace needs repairing by builder.

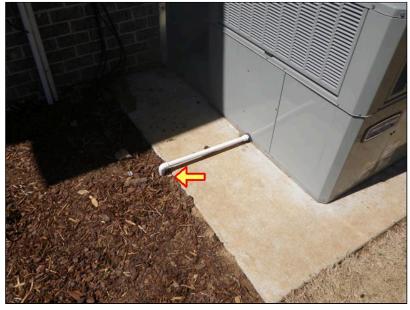
10.3 (Picture 1)

No visible trap on this line. It may be underground if not builder should correct as required.

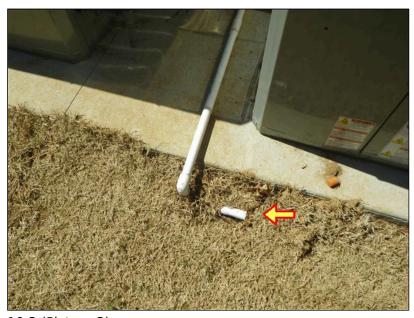
10.3 (Picture 3)

A condensation pit or well may be considered here. These are generally eight to 10 inches deep filled half with gravel and are located at condensation line termination points.

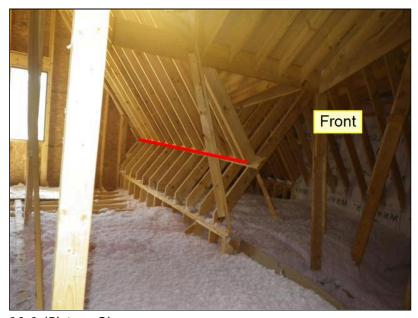
11.1 (Picture 2)

Numerous joists in the attic are missing strong ties that aid in supporting the joists at end cuts. Face nailing alone is not sufficient. Correction needed by builder.

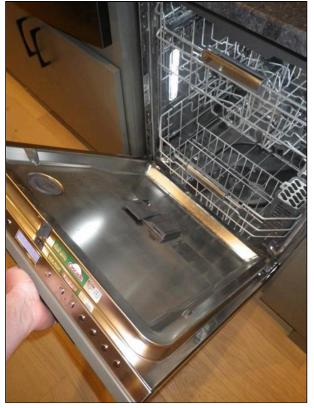
Dishwasher doors do not stay open on there own. Adjustment needed by builder.

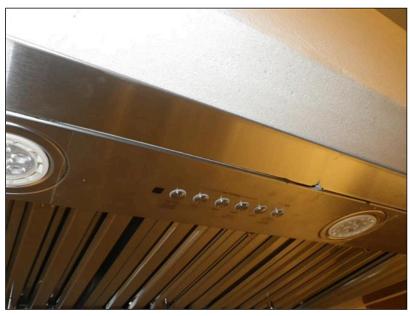
16.4 (Picture 1)

No power to vent hood at time of inspection. Builder to confirm proper operation of appliance.
