Inspection Report

Property Address: 123 Any Street TN

Home Inspectors of Middle Tennessee LLC

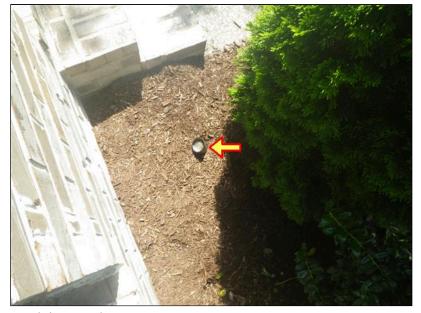
1.2 (Picture 1)

- **1.0** The lot appears to have adequate drainage to prevent water from ponding. Your inspector is not qualified to determine the makeup of the soil. If soil stability or expansive soil conditions are a concern, please consult a geotechnical engineer.
- **1.2** No inspection on exterior landscape lighting.

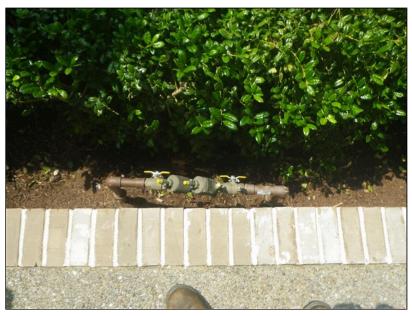
1.2 (Picture 2)

We have no way of inspecting irrigation systems. Irrigation system was not inspected by our company.

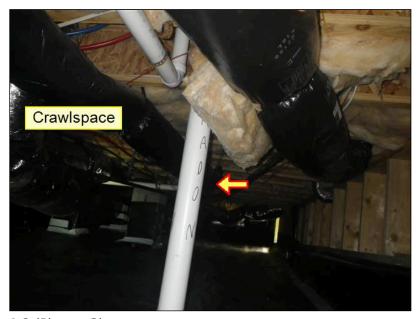
1.2 (Picture 3)

This home is equipped with a passive radon mitigation system. Radon evacuation plumbing is in place however no evacuation fan has been installed therefore system is inoperable.

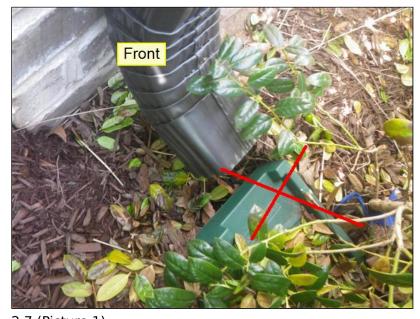
2.7 (Picture 1)

2.7 Drain extensions, above or below ground, extended at least 8-10 feet away from foundation will greatly assist in keeping the foundation walls and/or crawl space dry. Recommend drain extensions be installed at all applicable locations.

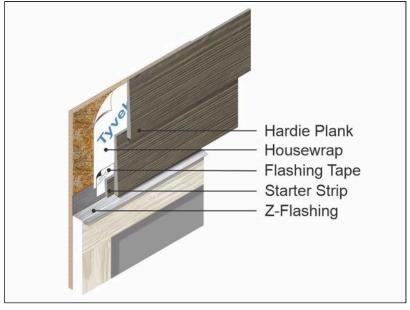
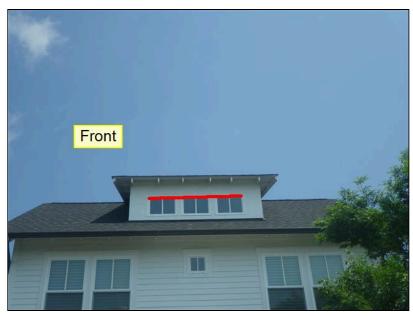
3.1 (Picture 1)

Missing counter flashing at the pictured locations. This flashing is needed above windows and doors as well as above blocked penetrations. This location may leak in the future if the flashing is not installed. I recommend the appropriate flashing be installed and this area be further inspected by a roofing professional.

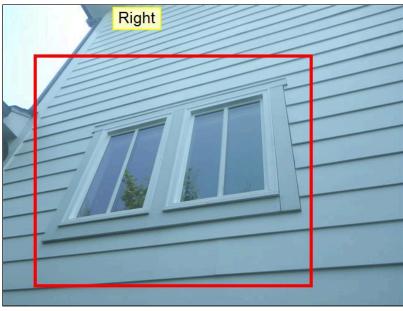
5.0 (Picture 1)

5.0 Windows have not been sealed in. Sealant needed where siding meets trim. Trim appears primed but not painted. Corrections needed by professional to prevent moisture intrusion and deterioration.

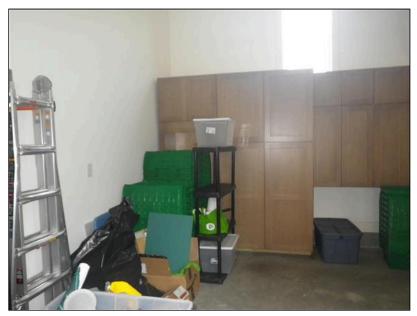
6.3 (Picture 1)

6.3 Inspection restrictions in garage.

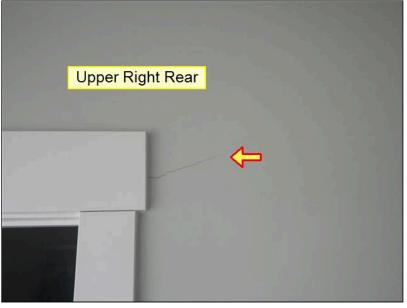
7.0 (Picture 1)

7.0 Crack observed at interior wall. All buildings settle with minor wall cracking visible at some point. Recommend patching and monitoring for further movement. Crack appears normal for a home this age.

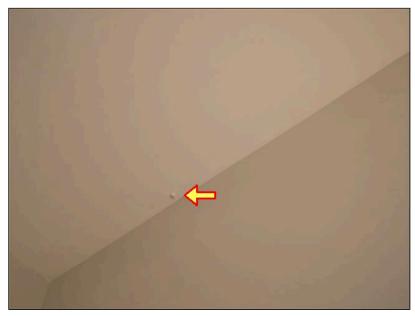
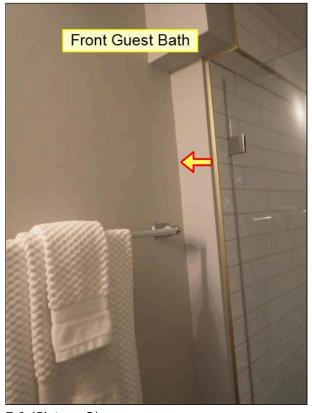
7.1 (Picture 1)

7.1 Miscellaneous nail pops and drywall tape seam cracks exist at various locations. Nails can be reset and covered with several coats of joint compound or spackle, lightly sand area and re paint. Tape seams can be repaired with several coats of joint compound, sanding and repainting.

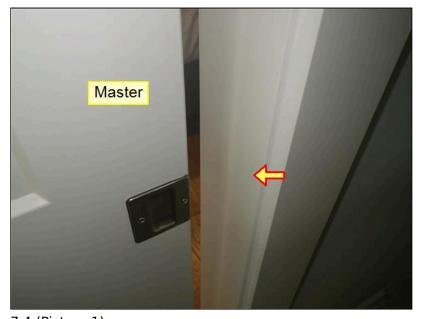
7.4 (Picture 1)

7.4 Missing hardware at pictured door needs correction.

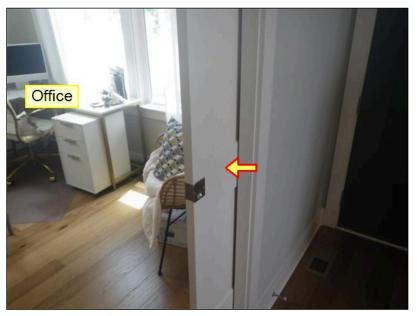
7.4 (Picture 2)

Pictured door needs to be adjusted to prevent sliding open/close on its own.

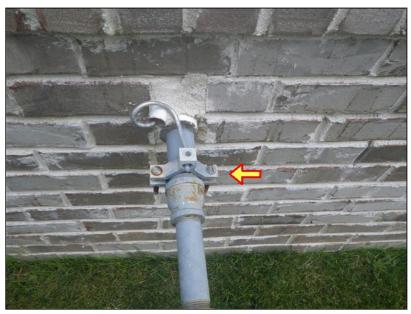
8.2 (Picture 1)

8.2 FYI - Bond wire located at gas meter.

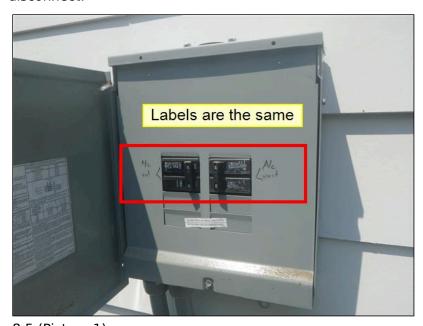
8.5 (Picture 1)

8.5 Labels should indicate the specific unit the breaker services. Correction needed at the HVAC disconnect.

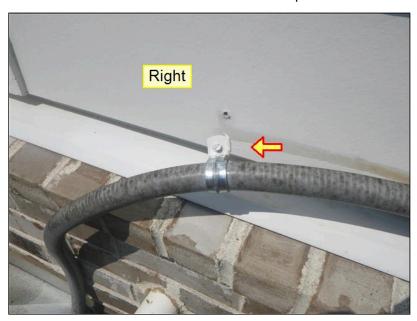
8.7 (Picture 1)

8.7 Electrical conduit has become loose at pictured location. Support needs re-attaching to siding.

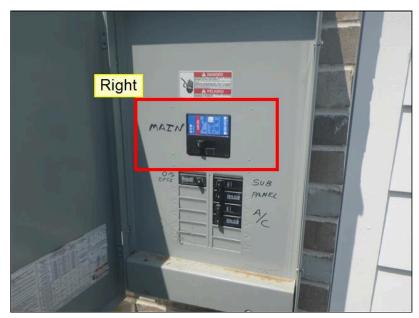
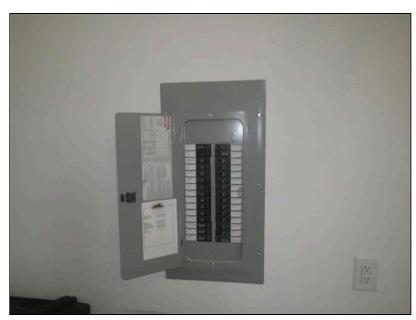
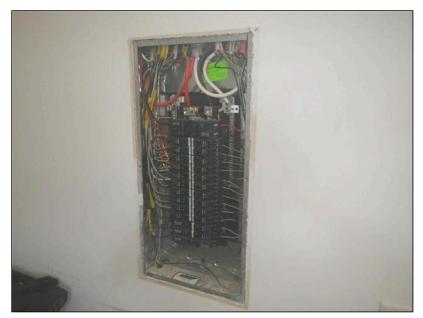
8.8 (Picture 1)

8.8 FYI - Main disconnect (shut-off) is outside at meter base. Main panel box is located in the garage.

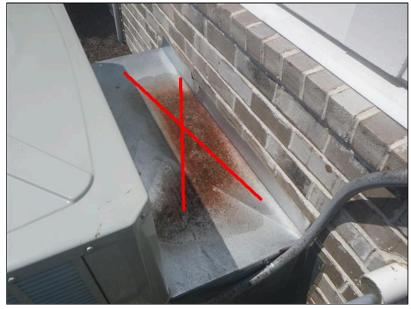
9.3 (Picture 1)

9.3 Package unit shroud has been holding water. This will cause premature deterioration and should be corrected by a qualified professional.

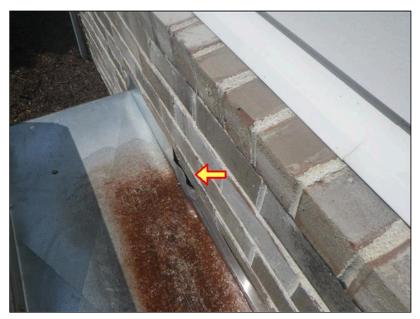
9.3 (Picture 2)

Package unit shroud is not fully sealed and may allow pest intrusion into crawlspace. Correction needed.

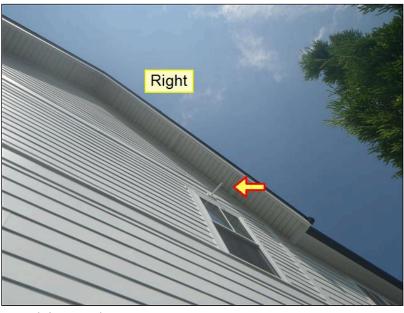
10.3 (Picture 1)

10.3 FYI -- If water is ever coming out of pictured PVC overflow for attic located air handler a certified HVAC technician should be consulted immediately for repairs. This would indicate primary condensate is stopped up.

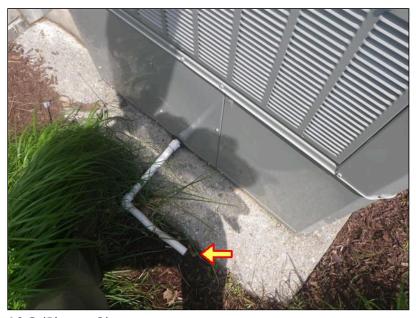
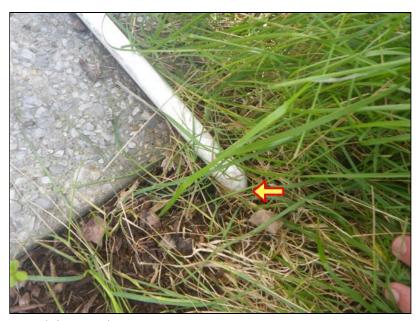
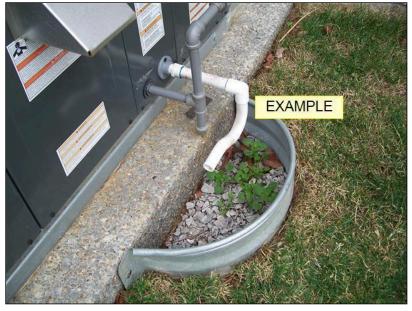
10.3 (Picture 2)

Additional clearance recommended at pictured condensation lines to prevent the lines from becoming clogged. A condensation pit or well may be considered. These are generally eight to 10 inches deep filled half with gravel and are located at condensation line termination points.

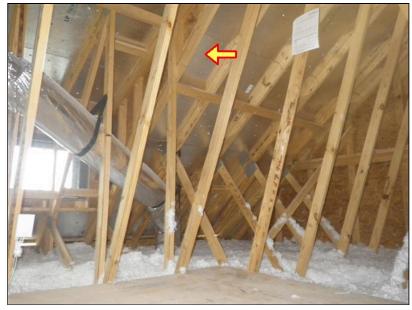
11.1 (Picture 1)

11.1 We do not walk open rafters. This is an unsafe practice which can result in damage to the home or inspector.

The installation of TechShield inhibits the inspection of the roof sheathing.

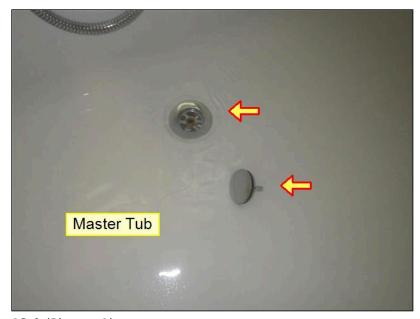
13.0 (Picture 1)

Stop valve disconnected at pictured fixture and should be corrected.

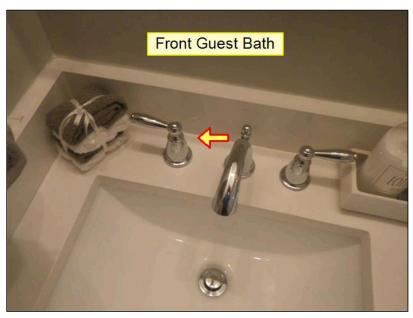
13.0 (Picture 2)

Pictured knob is loose and needs stabilizing to prevent leaks. Repair needed by plumber.

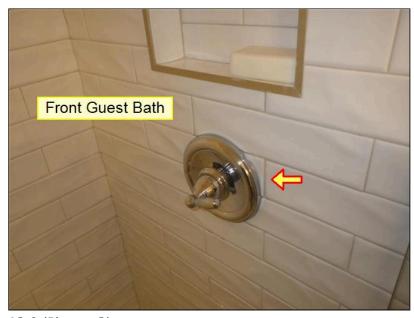
13.0 (Picture 3)

Pictured plumbing fixture has hot/cold reverse at the control knob. Correction needed. Hot should always be on the left when facing the fixture or indicated by a red symbol.

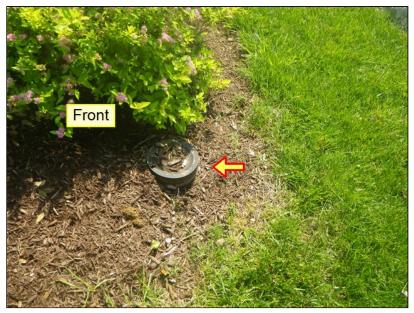
13.2 (Picture 1)

Recommend rubber cap be replaced with a PVC cap. These are more durable. Current cap may deteriorate especially if buried by mulch.

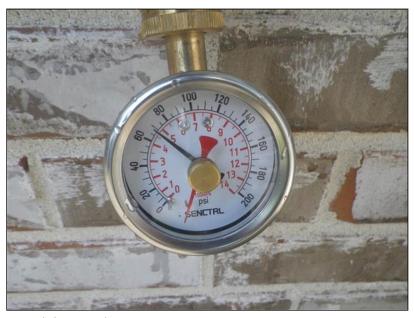
13.3 (Picture 1)

13.3 Water pressure at outside hose bib at time of inspection was between 60 and 80 psi which is an acceptable range.

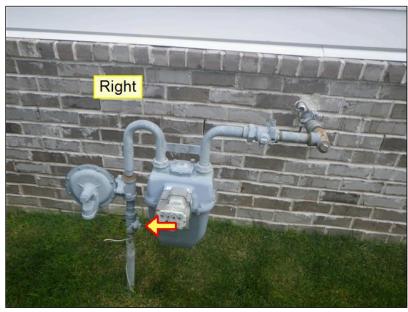
13.4 (Picture 1)

13.4 FYI - See photo for location of main gas "Shut-Off" valve. The main gas shut off valve is located at the meter base. This is important to know in case of an emergency. Valve can be turned to the off position with an adjustable wrench by a lining up the holes in the meter valve.

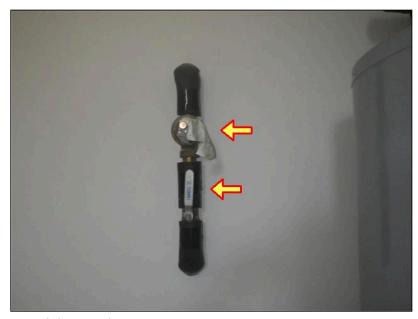
13.4 (Picture 2)

FYI - The main shut-off is the white lever/knob at the water heater.

The bell shaped object is your water pressure regulator valve. This may can be adjusted to increase or decrease water pressure.

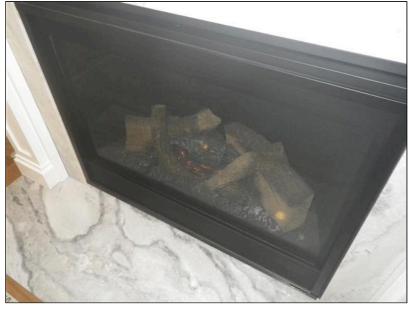
14.0 (Picture 1)

14.0 Virtually all manufactured fireplace inserts are accompanied with a "Data Plate". Please read this "Data Plate" and operate your fireplace in accordance with the manufacturer's suggested guidelines. Failure to do so may result in a fire or damage to the fireplace.

Functions as intended.

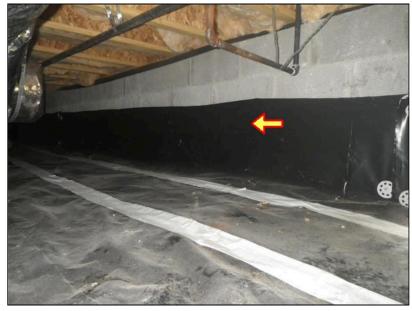
15.0 (Picture 1)

15.0 Most of the foundation wall, band joist and sill plate was not visible due to insulation.

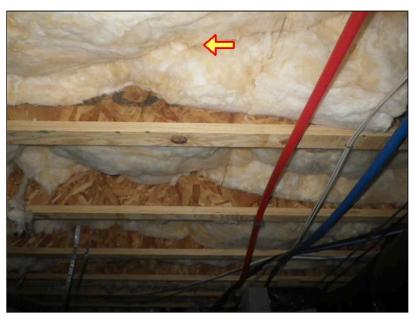
15.1 (Picture 1)

15.1 Most of the floor structure was not visible for inspection due to floor insulation.

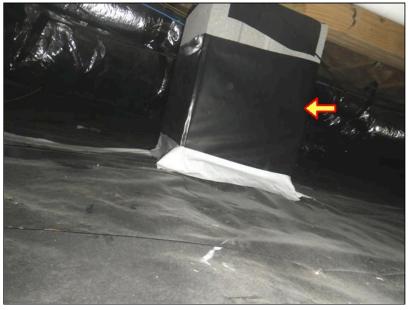
15.2 (Picture 1)

15.2 Piers are wrapped in vapor barrier. Unable to see most of the piers.

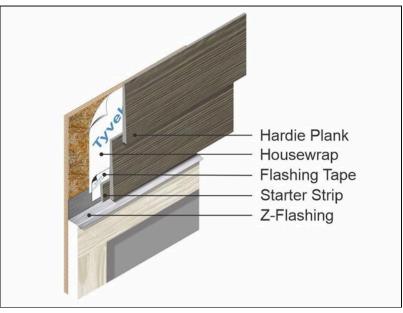
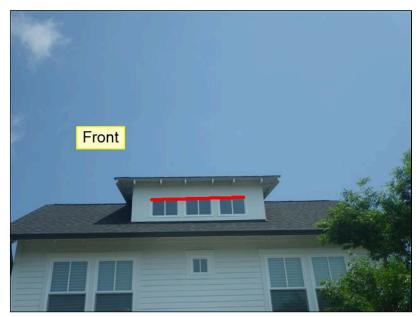
3.1 (Picture 1)

as above blocked penetrations. This location may leak in the future if the flashing is not installed. I recommend the appropriate flashing be installed and this area be further inspected by a roofing professional.

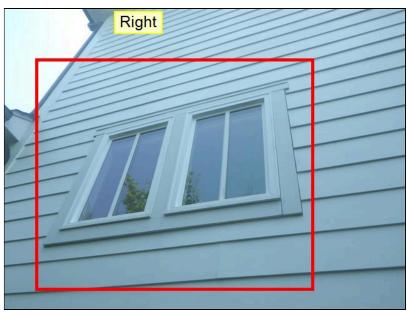
5.0 (Picture 1)

Windows have not been sealed in. Sealant needed where siding meets trim. Trim appears primed but not painted. Corrections needed by professional to prevent moisture intrusion and deterioration.

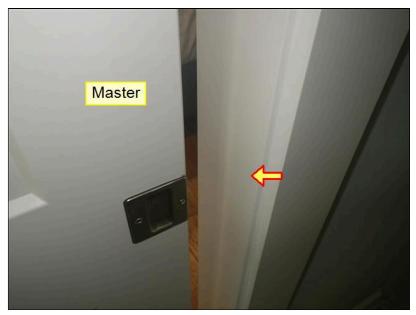
7.4 (Picture 1)

Missing hardware at pictured door needs correction.

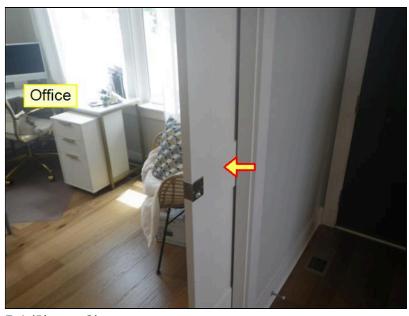
7.4 (Picture 2)

Pictured door needs to be adjusted to prevent sliding open/close on its own.

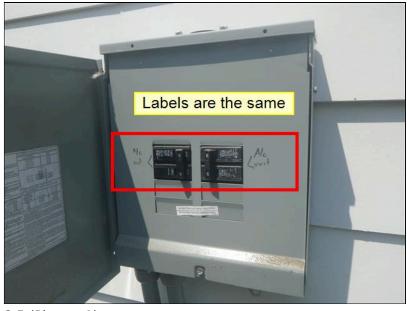
8.5 (Picture 1)

Labels should indicate the specific unit the breaker services. Correction needed at the HVAC disconnect.

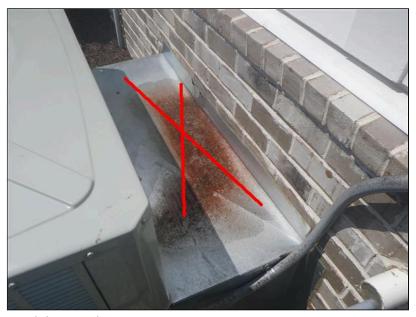
9.3 (Picture 1)

Package unit shroud has been holding water. This will cause premature deterioration and should be corrected by a qualified professional.

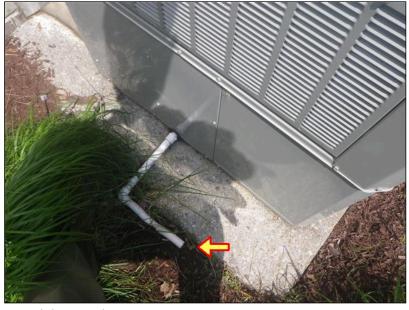
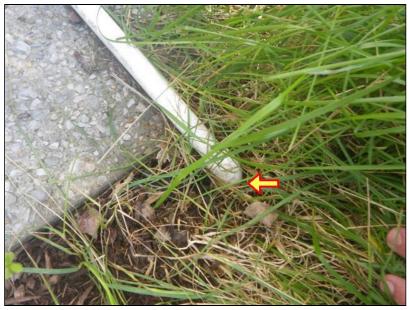
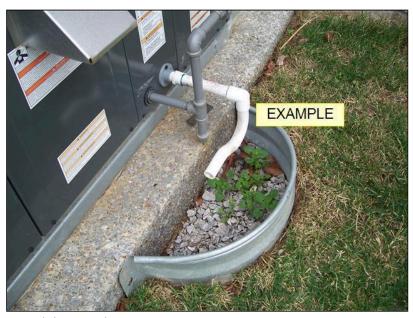
10.3 (Picture 2)

Additional clearance recommended at pictured condensation lines to prevent the lines from becoming clogged. A condensation pit or well may be considered . These are generally eight to 10 inches deep filled half with gravel and are located at condensation line termination points.

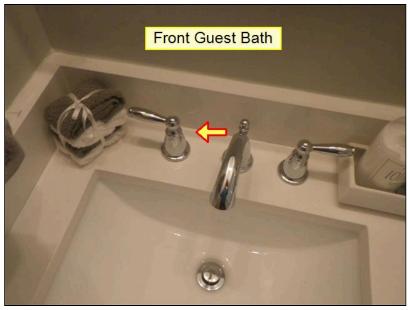
13.0 (Picture 2)

Pictured plumbing fixture has hot/cold reverse at the control knob. Correction needed. Hot should always be on the left when facing the fixture or indicated by a red symbol.
