Inspection Report

Property Address: 123 Any Street TN

Home Inspectors of Middle Tennessee LLC

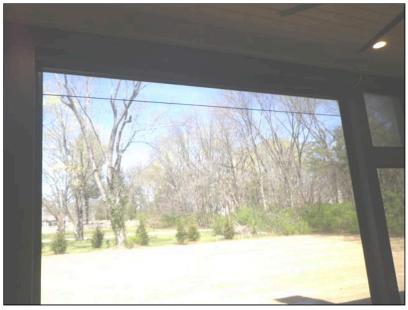
1.2 (Picture 4)

This is new construction and some items are "unfinished".

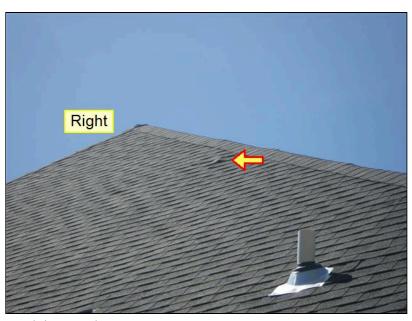
2.1 (Picture 2)

2.1 Nail pop present at pictured location. This is generally caused when the shingle nails are driven at an incorrect angle or the air nailer does not have enough pressure. If left unattended the nails can force through the shingles. Repairs needed.

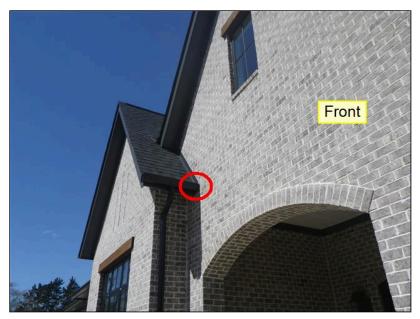
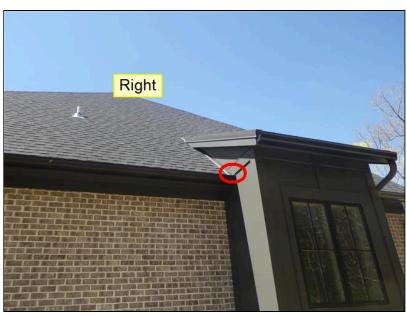
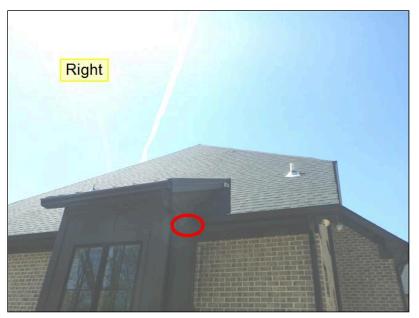
2.3 Kick out diverter flashing needed anywhere a roof and exterior wall intersect, where the wall continues past the lower roof-edge and gutter. Recommend builder evaluate further and make repairs where needed. (Required since 2009)

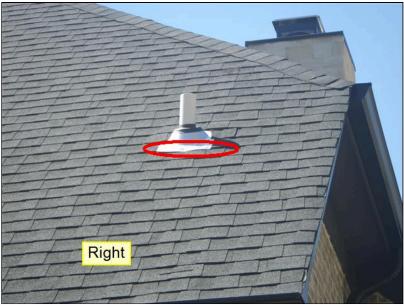
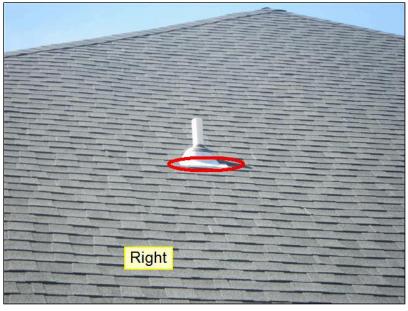
2.5 Nail penetrations are an obvious source of potential moisture intrusion. All exposed nail heads must be sealed as per most shingle manufacture installation guidelines. While repairs are being made I recommend builder inspect all roof penetrations.

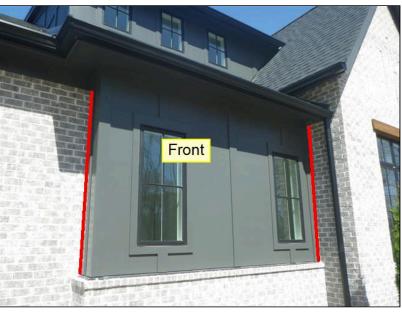
3.1 (Picture 2)

Counter flashing needed anywhere brick meets cement fiber board to prevent moisture intrusion. Builder to further evaluate and repair as needed. Not all locations pictured.

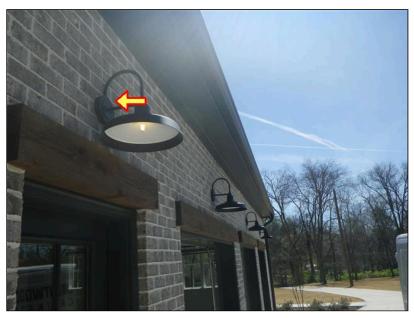
3.1 (Picture 3)

Ideally all light fixtures should be sealed to siding material with high quality silicone. Not all pictured.

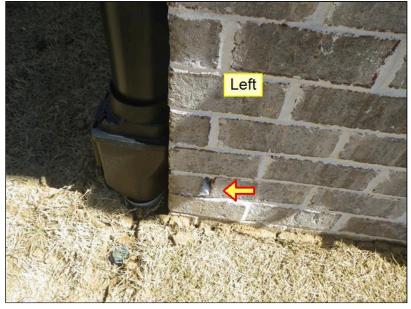
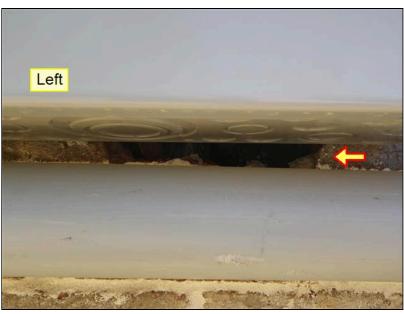
3.2 Masonry repair needed at the pictured areas. Builder to correct.

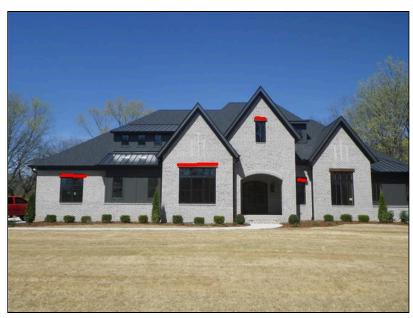
3.2 (Picture 5)

The 1995 CABO (Council of American Building Officials) and the 1994 Standard Building Code call for flashings and weep holes in masonry veneer. Weep holes were not installed on this home at some locations. Weep holes are intended to allow water to exfiltrate and air to infiltrate the wall cavity. Ideally weep holes should be provided in masonry veneer and in the outside wythe of the masonry walls at a maximum spacing of 4 feet on center by omitting mortar in the head joints. Weep holes should be located in the first course above the foundation wall or slab, and other points of support, including structural floors, shelf angles, and lintels above windows. Correction needed at all applicable locations.

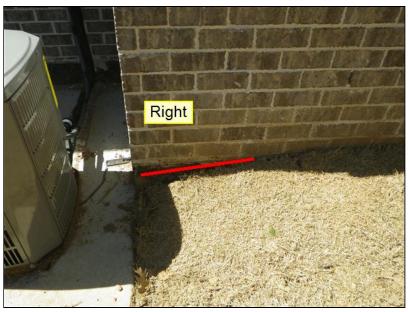
3.2 (Picture 7)

Masonry repair needed at pictured location where foundation block is visible. Builder to correct.

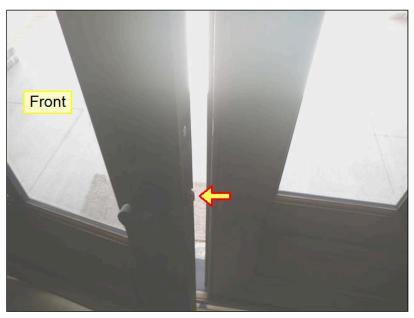
5.2 (Picture 1)

5.2 Door hardware needs adjusting at pictured location.

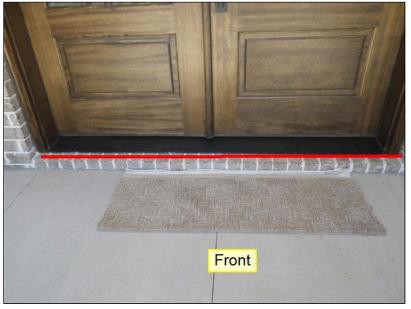
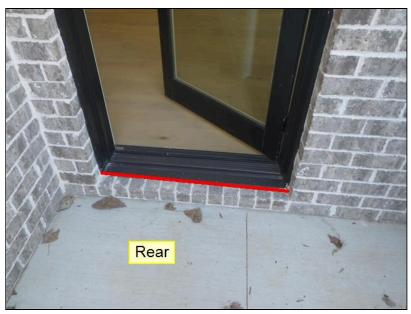
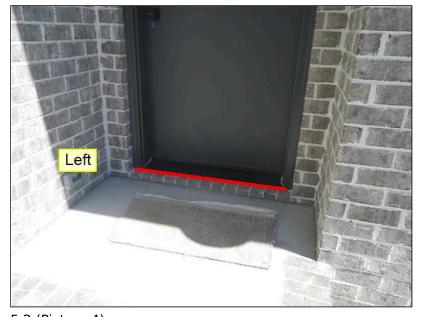
All exposed threshold plates need sealing with silicone.

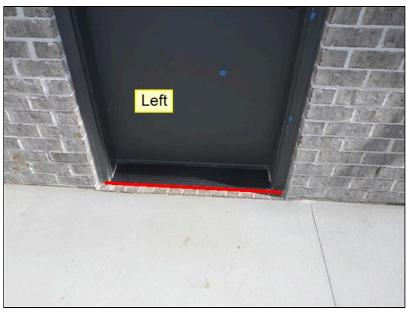
5.2 (Picture 5)
Pictured door would not open. Builder to correct.

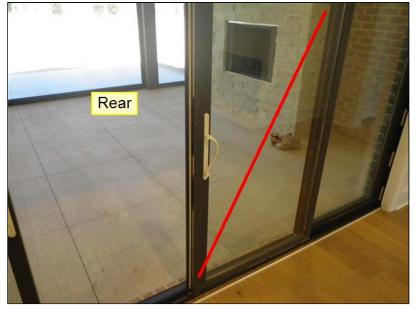
5.2 (Picture 6)
Pictured door rubs and needs adjustment.

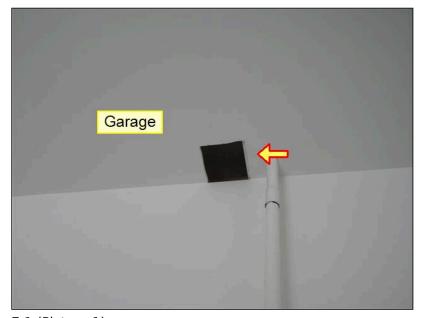
7.1 (Picture 1)

7.1 Builder to patch opening in drywall.

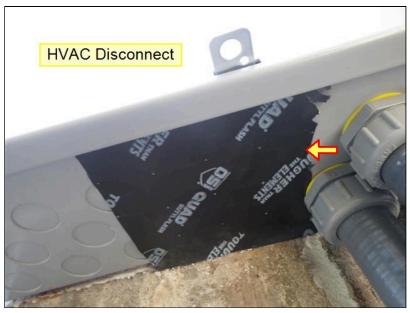
8.4 (Picture 1)

8.4 Knock out seals needed in lieu of tape as this is a temporary solution. Builder to correct.

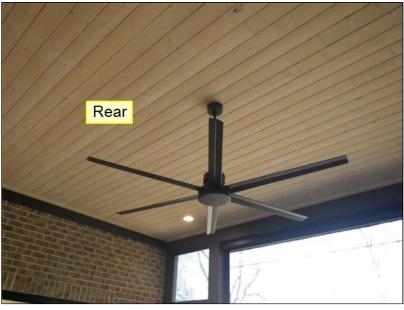
8.7 (Picture 1)

8.7 I was unable to get the pictured fan to spin during the inspection. Correction needed.

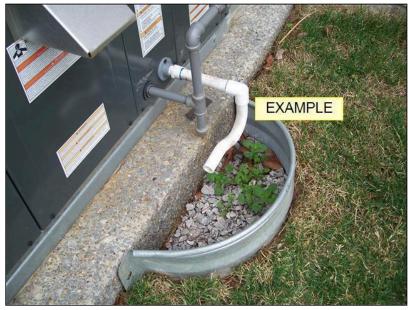
10.3 (Picture 2)

Additional clearance recommended at pictured condensation line to prevent the line from becoming clogged.

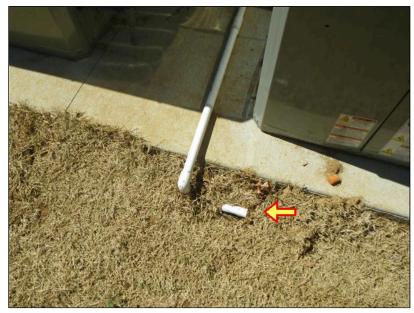
10.3 (Picture 3)

A condensation pit or well may be considered here. These are generally eight to 10 inches deep filled half with gravel and are located at condensation line termination points.

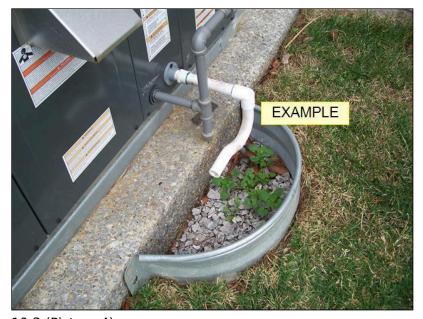
10.3 (Picture 4)

Recommend extending condensation and/or overflow lines at least six feet away from home. These lines carry large volumes of water during high use periods. A condensation pit or well may also be considered. These are generally eight to ten inches deep filled half with gravel and are located at condensation line termination points.

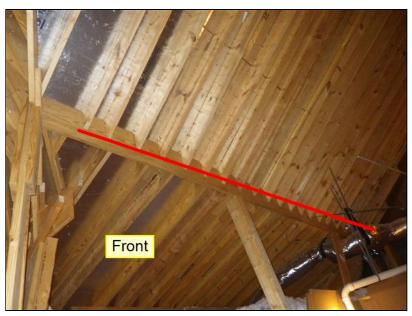
11.1 (Picture 3)

Numerous joists in the attic are missing strong ties that aid in supporting the joists at end cuts. Face nailing alone is not sufficient. Correction needed by builder.

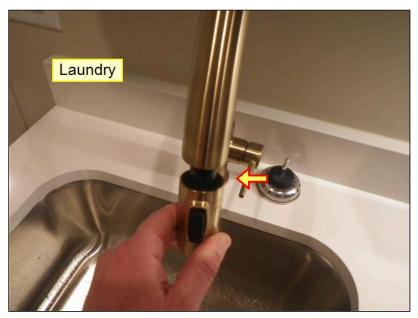
13.0 (Picture 2)

Pictured fixture spray nozzle does not extend properly. Adjustment needed.

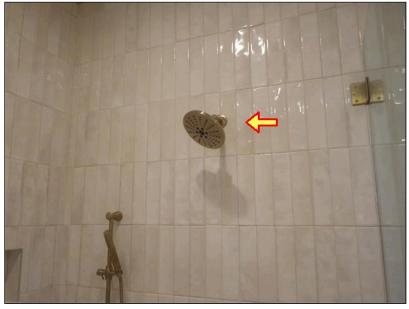
13.0 (Picture 3)

Water did not emit from master shower heads. Builder to further inspect and correct.

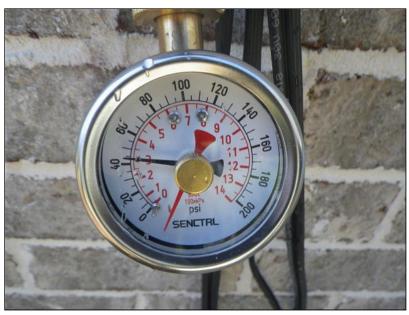
13.3 (Picture 1)

13.3 Water pressure at the time of the inspection was below 60 PSI. Ideal water pressure is between 60 and 80 PSI. Advise adjusting pressure reducing valve to attain more pressure.

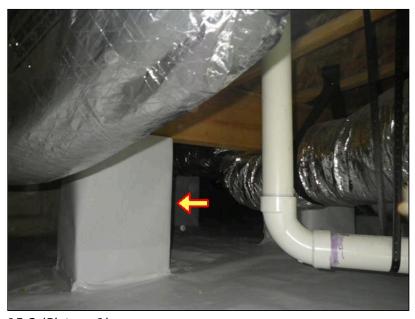
15.2 (Picture 1)

15.2 Piers are wrapped in vapor barrier. Unable to see most of the piers.

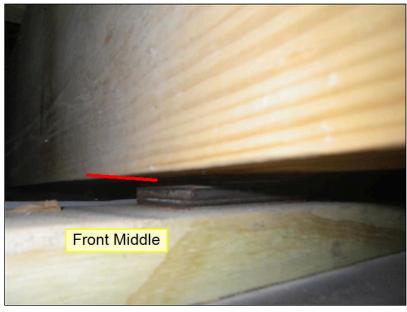
15.2 (Picture 2)

On several piers the shims supporting the girder on the piers are not properly placed to provide minimum 1 1/2" end bearing for all plies of the girders including both sides of splices in the girder plies. Builder should check all piers and add additional shims to the piers as necessary so that all plies of all girders have a minimum 1 1/2" of bearing on both sides of splices on each pier.

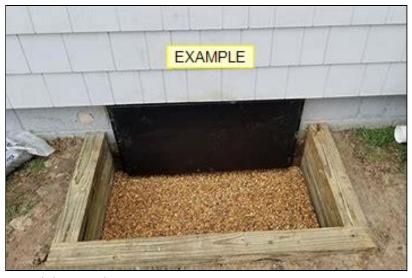
15.5 (Picture 1)

Crawl space entry door is at ground level. I recommend a drainage window well be installed with a layer of gravel a couple of inches below the bottom of the door to prevent water intrusion.

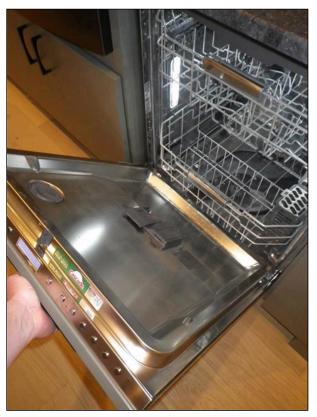
16.0 (Picture 1)

16.0 Dishwasher doors do not stay open on there own. Adjustment needed by builder.

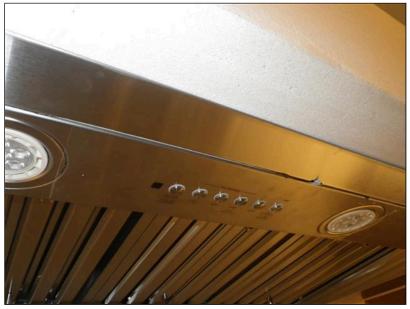
16.4 (Picture 1)

16.4 No power to vent hood at time of inspection. Builder to confirm proper operation of appliance.

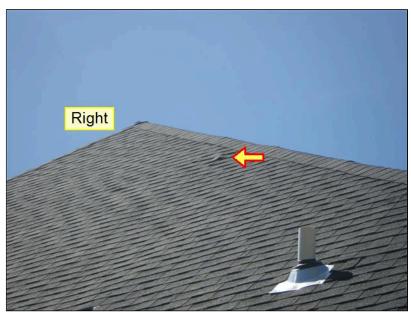
2.1 (Picture 2)

Cricket for chimney appears undersized due to slope of roof. While I cannot confirm, I recommend ensuring with the builder this cricket is sufficient to divert water and prevent leakage.

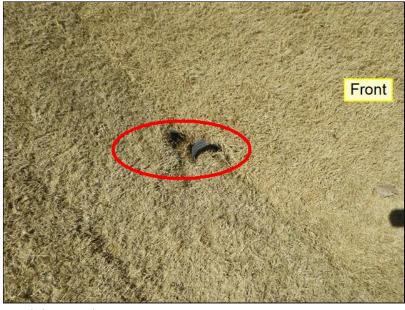
2.7 (Picture 2)

Landscape pop ups or screens at drain extensions need installing to prevent extensions from clogging.

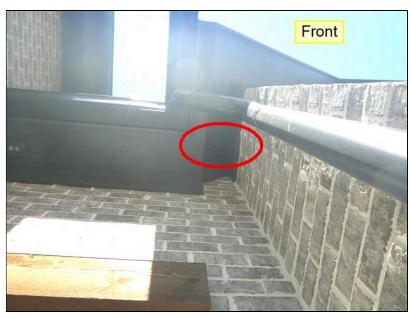
3.0 (Picture 1)

Gap at soffit is large enough for bird and insect entry. Correction needed.

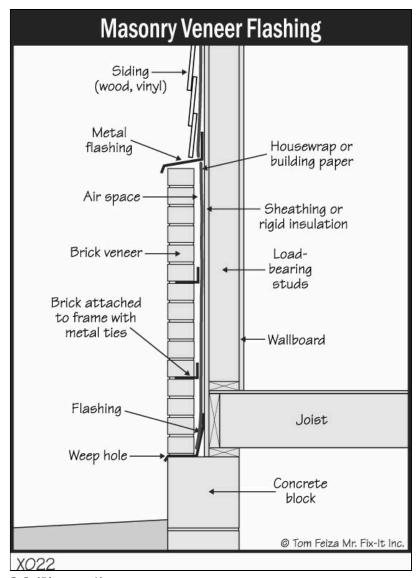
3.2 (Picture 4)

The 1995 CABO (Council of American Building Officials) and the 1994 Standard Building Code call for flashings and weep holes in masonry veneer. Weep holes were not installed on this home at some locations. Weep holes are intended to allow water to exfiltrate and air to infiltrate the wall cavity. Ideally weep holes should be provided in masonry veneer and in the outside wythe of the masonry walls at a maximum spacing of 4 feet on center by omitting mortar in the head joints. Weep holes should be located in the first course above the foundation wall or slab, and other points of support, including structural floors, shelf angles, and lintels above windows. Correction needed at all applicable locations.

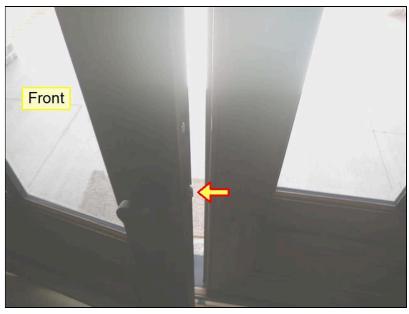
Door hardware needs adjusting at pictured location.

5.2 (Picture 1)
All exposed threshold plates need sealing with silicone.

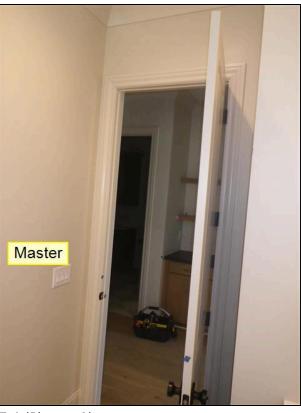
7.4 (Picture 1)

Pictured door needs to be adjusted to prevent swinging open/close.

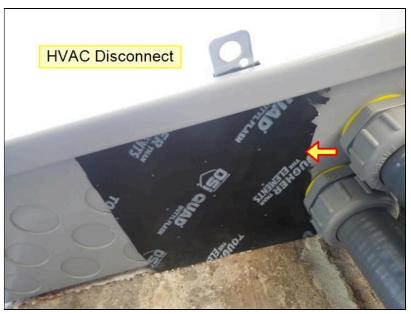
8.4 (Picture 1)

Knock out seals needed in lieu of tape as this is a temporary solution. Builder to correct.

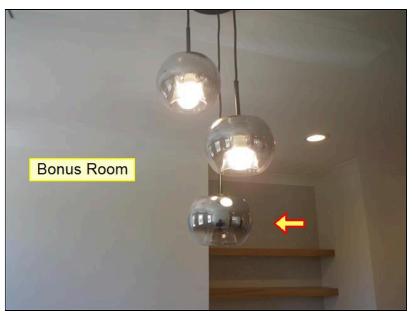
8.7 (Picture 2)

Missing bulb. Correction needed.

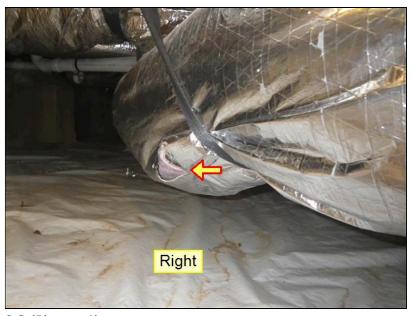
9.3 (Picture 4)

Damaged duct insulation in crawlspace needs repairing by builder.

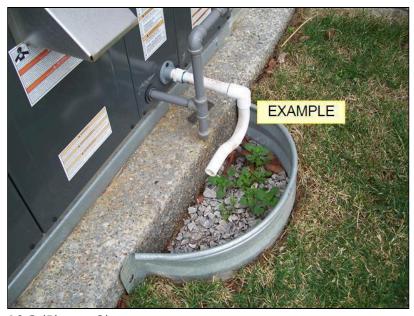
10.3 (Picture 2)

Condensation lines should not be terminating under ground as this can cause the lines to back up which will cause failure or damage to the unit. Correction needed. A condensation pit or well may also be considered. These are generally 8 to 10 inches deep filled half with gravel and are located at condensation line termination points.

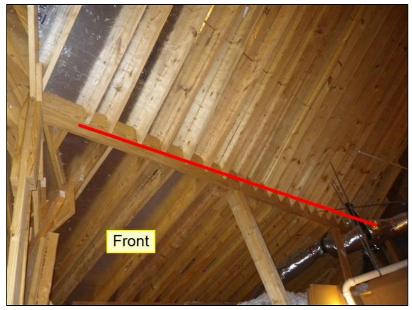
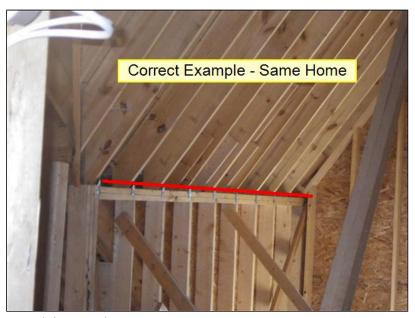
Numerous joists in the attic are missing strong ties that aid in supporting the joists at end cuts. Face nailing alone is not sufficient. Correction needed by builder.

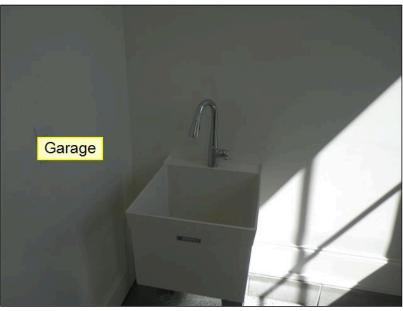
13.0 (Picture 1)

Water off to pictured fixture. Builder to ensure proper functionality of component.

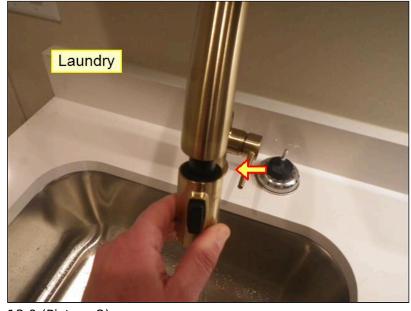
13.0 (Picture 2)

Pictured fixture spray nozzle does not extend properly. Adjustment needed.

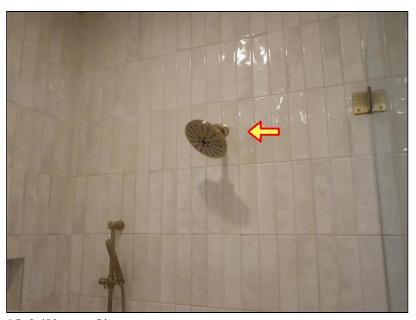
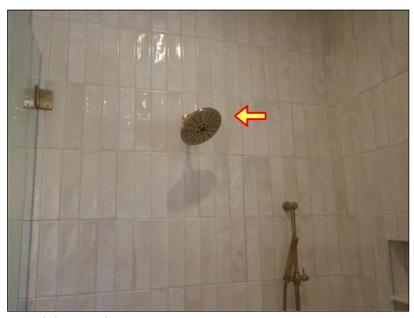
Water did not emit from master shower heads. Builder to further inspect and correct.

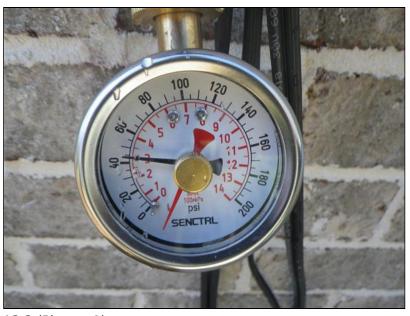
13.3 (Picture 1)

Water pressure at the time of the inspection was below 60 PSI. Ideal water pressure is between 60 and 80 PSI. Advise adjusting pressure reducing valve to attain more pressure.

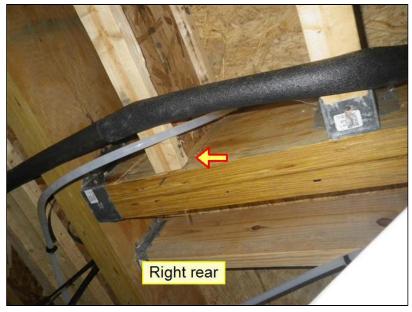
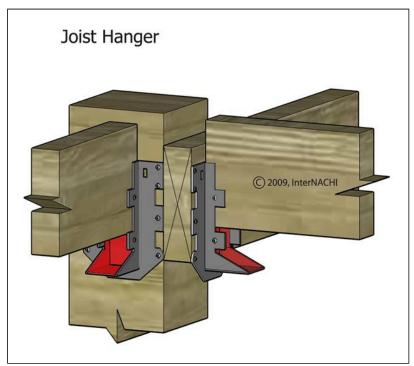
Pictured floor joist is missing joist hanger. Face nailing alone is not sufficient. Recommend builder evaluate further and make appropriate repair.

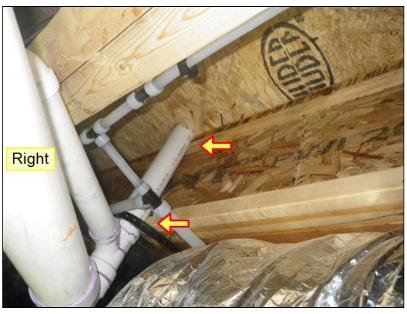
15.1 (Picture 3)

Truss joist installation guidelines indicate "do not cut or notch flange". Doing so weakens the joist. Pictured flange is damaged by tradesmen and needs repair or replace per manufacturers guidelines. Further evaluation and repair by builder is needed.

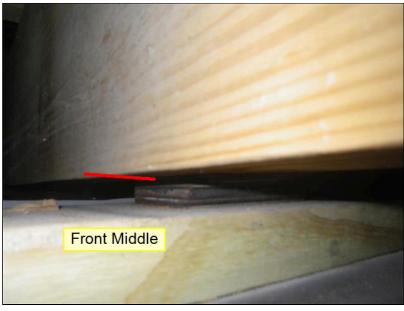
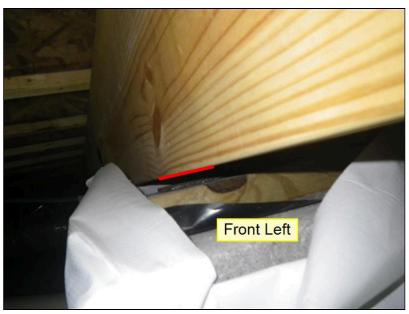
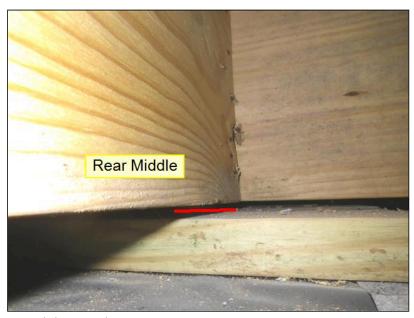
On several piers the shims supporting the girder on the piers are not properly placed to provide minimum $1\ 1/2$ " end bearing for all plies of the girders including both sides of splices in the girder plies. Builder should check all piers and add additional shims to the piers as necessary so that all plies of all girders have a minimum $1\ 1/2$ " of bearing on both sides of splices on each pier.

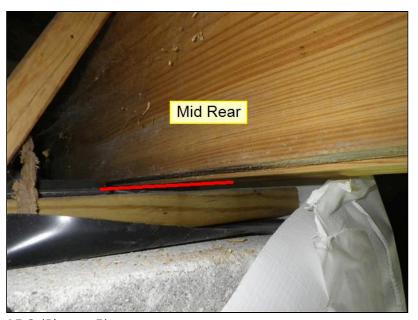
15.2 (Picture 5)

At least one pier in the crawl space is not shimmed to the adjacent girder. Proper shimming required to provide adequate support. While repairs are being made suggest all piers be reinspected and repaired if needed.

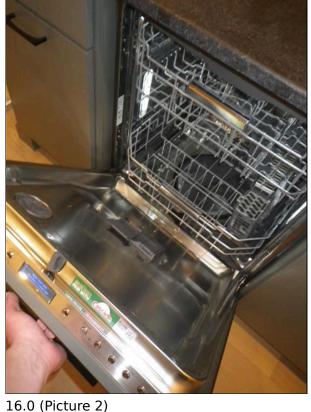
16.0 (Picture 1)

Dishwasher doors do not stay open on there own. Adjustment needed by builder.
